**Flood Control Project Maintenance
Levee Inspections**

Fall 2015 Levee Maintenance Deficiency Summary Report

San Joaquin River Basin

Reclamation District No. 0017 Mossdale

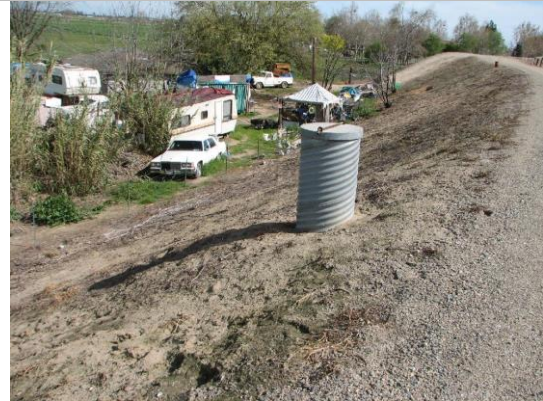
Photo 2 of 3 : UCIP_FA_2015_5506.jpg

CMP riser located on landward slope.

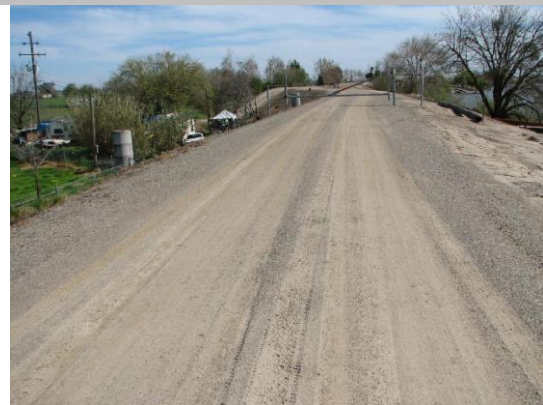
Photo 3 of 3 : UCIP_FA_2015_5507.jpg

Overview of levee crown at crossing.

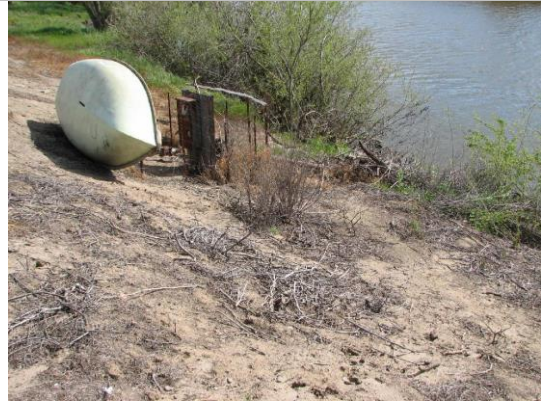
Photo 1 of 3 : UCIP_FA_2015_5508.jpg

Abandoned boat protecting pump station located on waterward side.

Action/Comments					
Inspector Comments: FS_ID:40680 DS_ID:43 EP_NO: 15078 FS_HLM: 7.291 Repair Type: Non-Urgent Crossing Status: Found UCIP Comments: Crossing is non-functional recommend contacting owner to determine status of crossing. If crossing is no longer used need to coordinate with CVFPB for proper abandonment. FIELD_STRUCT_DESC: 4 inch diameter pipeline through levee. Invert of pipe is 3.22 feet below levee crown. Siphon breaker on landward shoulder. Pump on waterward berm. (Permit No. 15078-1989) FS Date: 02/04/2010

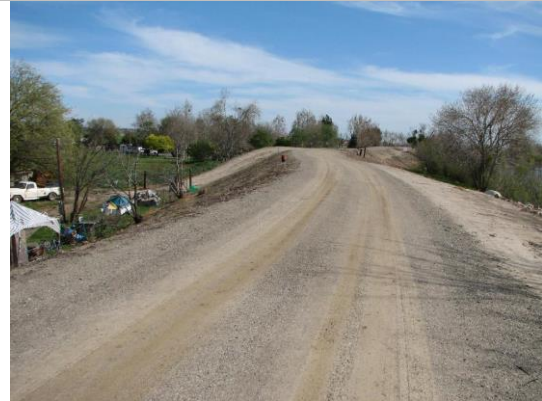
Photo 2 of 3 : UCIP_FA_2015_5509.jpg

Overview of levee crown at crossing.

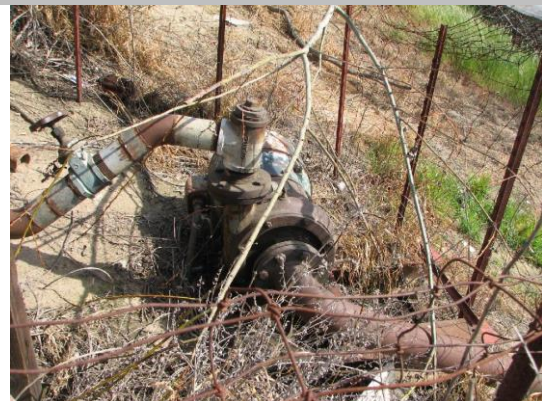
Photo 3 of 3 : UCIP_FA_2015_5989.jpg

Motor located on waterward slope.

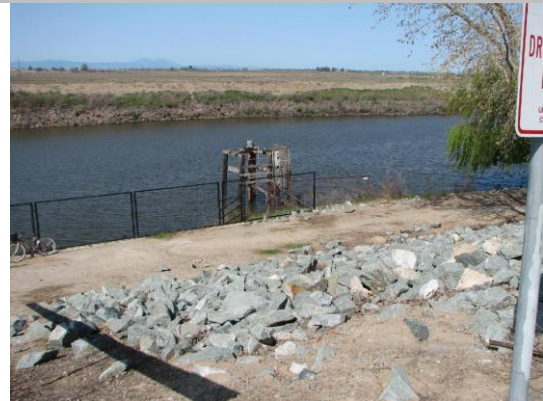
Photo 1 of 3 : UCIP_FA_2015_6539.jpg

View of waterward side.

Inspector Comments: FS_ID:40681
 DS_ID:44
 EP_NO: 15079
 FS_HLM: 7.5268
 Repair Type: Non-Urgent
 Crossing Status: Found
 UCIP Comments: If crossing is no longer in use owner will need to coordinate with DWR inspector and CVFPB to remove according to Title 23 requirements. Unable to determine if crossing is in use.
 FIELD_STRUCT_DESC: 14 inch pipeline through levee. Invert of pipe is 4.28 feet below levee crown. Siphon breaker on waterward shoulder. Pump on platform in channel, walkway from pump platform to the top of the riverbank, standpipe located 12 feet from landward tee. (Permit No. 15079-1990)
 FS Date: 02/04/2010

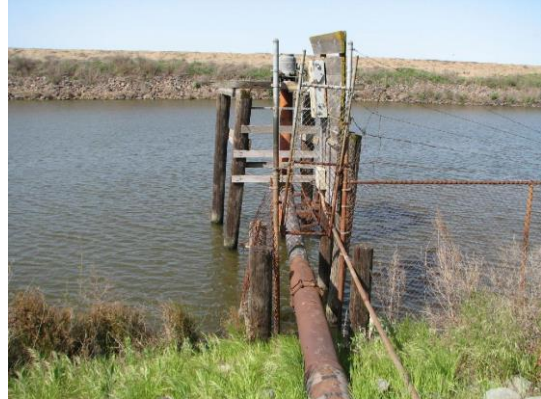
Photo 2 of 3 : UCIP_FA_2015_6553.jpg

Pipe, pump, and platform located on waterward side.

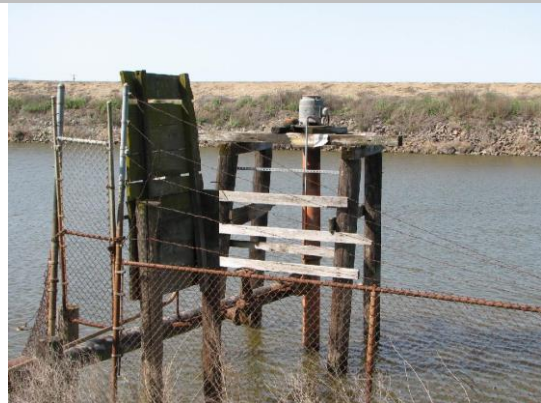
Photo 3 of 3 : UCIP_FA_2015_6555.jpg

Pump station fenced off on waterward side.

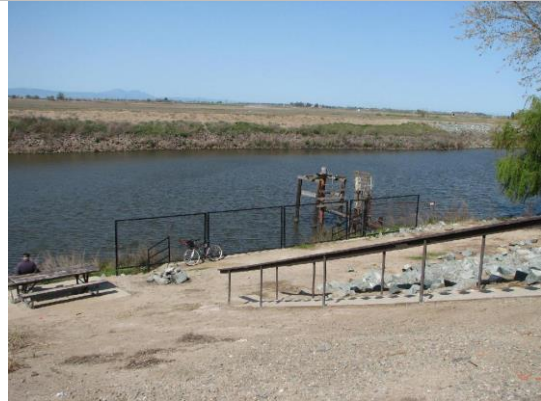
Photo 1 of 3 : UCIP_FA_2015_6536.jpg

LM Start	7.44	Rating **	M	Issue No.	600
LM End	7.44	Issue Type +	En	Location *	LS
Category	Supplemental			GPS Latitude/Longitude	
				Start	End
Item	DWR UCIP Field Study			37.830115 °	37.830115 °
				-121.310908 °	-121.310908 °
DWR ID					
Action/Comments					
Inspector Comments: FS_ID:40682					
DS_ID:99					
EP_NO: 17643					
FS_HLM: 7.5298					
Repair Type: Non-Urgent					
Crossing Status: Found

View of waterward side.

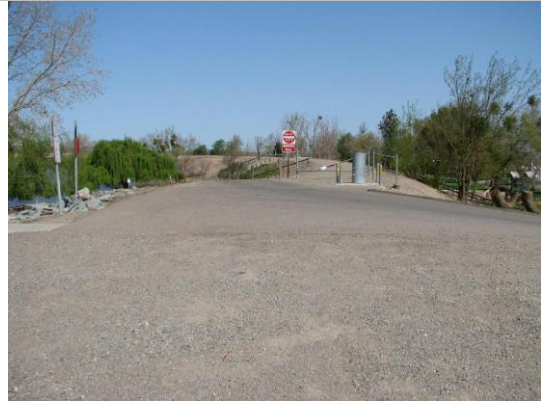
Photo 3 of 3 : UCIP_FA_2015_6538.jpg

Overview of levee crown at crossing.

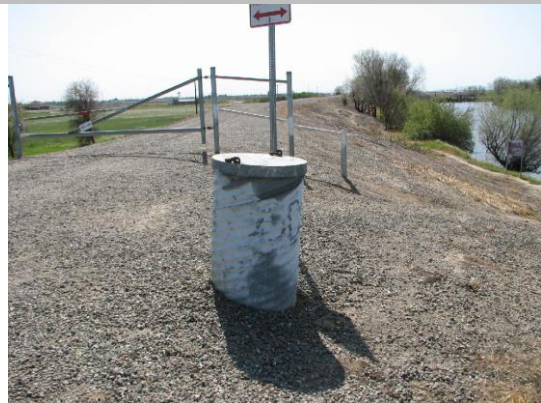
Photo 1 of 3 : UCIP_FA_2015_6554.jpg

CMP riser located on waterward shoulder.

Inspector Comments: FS_ID:40683
 DS_ID:284
 EP_NO: 15079
 FS_HLM: 7.5429
 Repair Type: Non-Urgent
 Crossing Status: Found
 UCIP Comments: Potential leak at standpipe--unable to confirm if crossing is operable. If crossing is no longer in use owner will need to coordinate with DWR inspector and CVFPB to remove according to Title 23 requirements. Unable to determine if crossing is in use.
 FIELD_STRUCT_DESC: 2 of 2. 10 inch pipe also referenced as 478+22, old 6 inch pipe was removed per encroachment recordation.
 FS Date: 02/04/2010

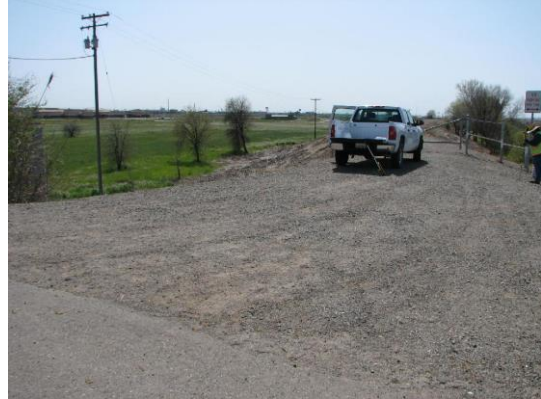
Photo 2 of 3 : UCIP_FA_2015_6556.jpg

Overview of levee crown at crossing.

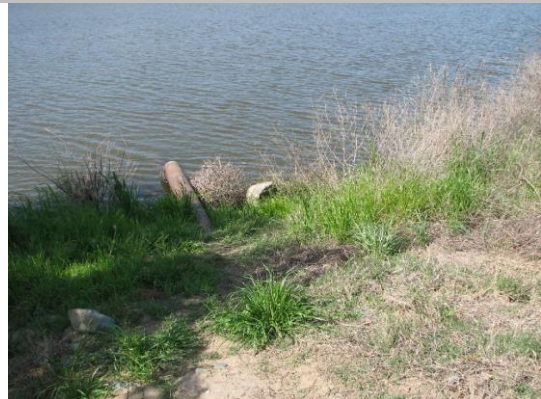
Photo 3 of 3 : UCIP_FA_2015_6558.jpg

Pipe visible on waterward side.

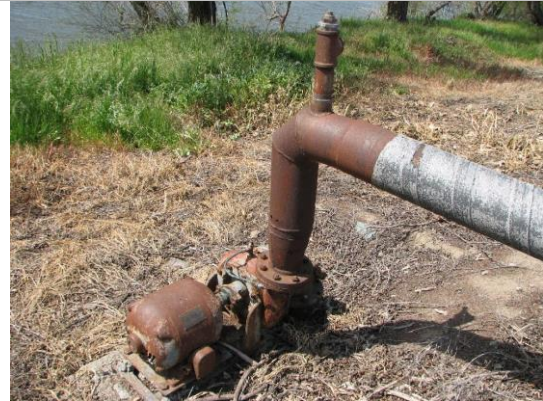
Photo 1 of 3 : UCIP_FA_2015_6557.jpg

Pump and pipe located on waterward slope.

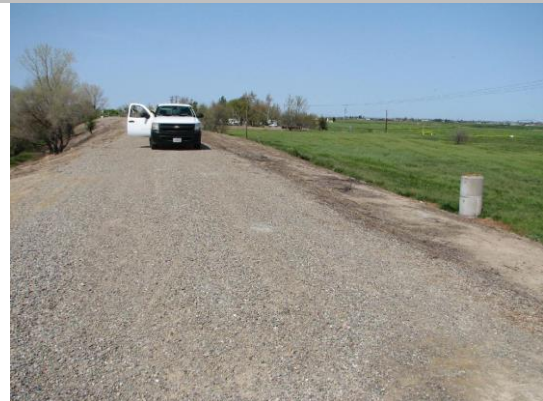
Photo 2 of 3 : UCIP_FA_2015_6559.jpg

Overview of levee crown at crossing.

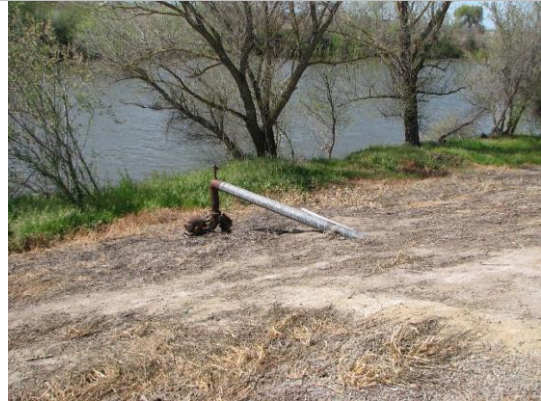
Photo 3 of 3 : UCIP_FA_2015_6560.jpg

View of waterward side.

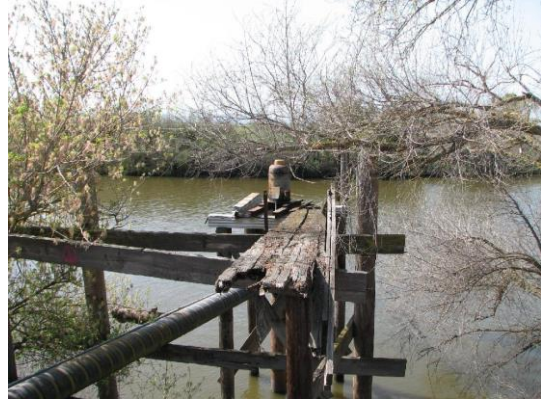
Photo 1 of 3 : UCIP_FA_2015_6561.jpg

Inspector Comments: FS_ID:40685
 DS_ID:98
 EP_NO: 15081
 FS_HLM: 7.812
 Repair Type: Non-Urgent
 Crossing Status: Found
 UCIP Comments: Erosion present on waterward toe underneath piles.
 Need to coordinate with owner to address issue on waterward side and to determine status of crossing.
 FIELD_STRUCT_DESC: 16 inch diameter asphalt coated and wrapped steel irrigation pipe through the levee 2.6-feet below the crown. Siphon breaker located on landward side. Stand pipe located at landward toe.
 Pump on Platform at WS toe Permit No. 15081, 1989.
 FS Date: 02/04/2010

Pump station located on platform located on waterward side.

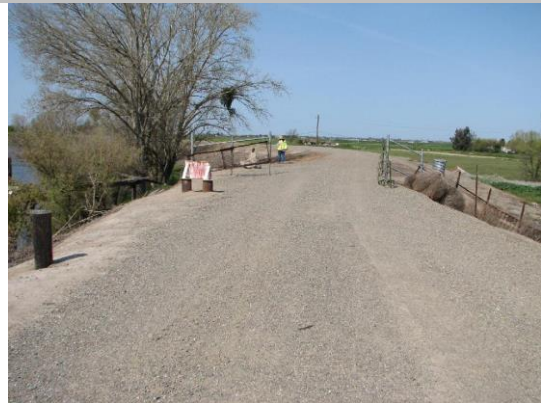
Photo 2 of 3 : UCIP_FA_2015_6562.jpg

Overview of levee crown at pipe crossing.

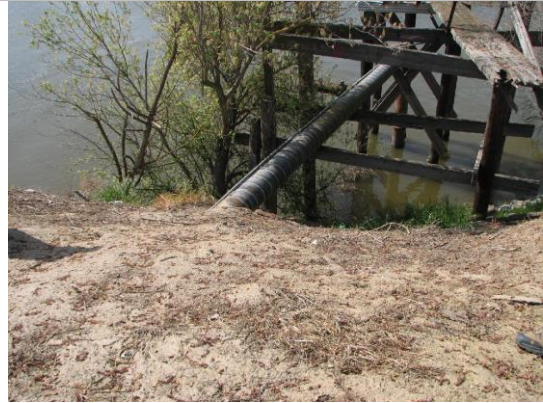
Photo 3 of 3 : UCIP_FA_2015_6678.jpg

Pipe daylight on waterward side.

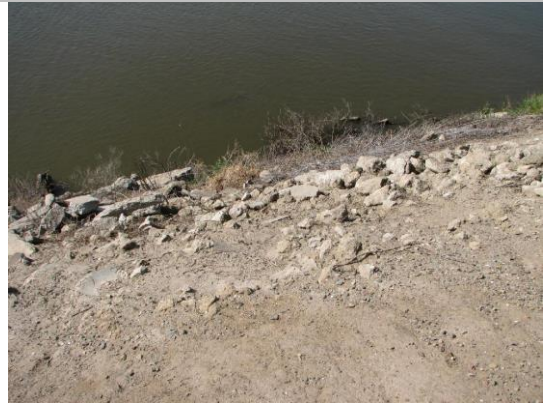
Photo 1 of 2 : UCIP_FA_2015_6679.jpg

View of waterward side.

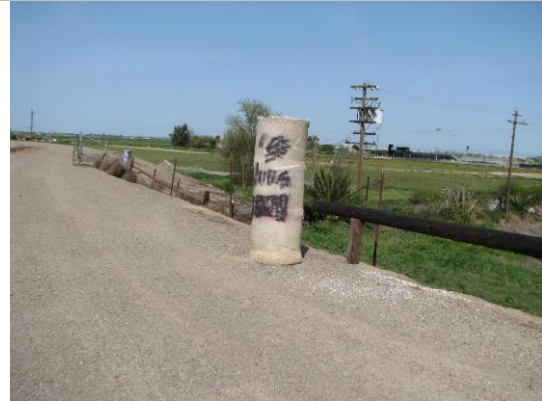
Photo 2 of 2 : UCIP_FA_2015_6680.jpg

Inspector Comments: FS_ID:40686
 DS_ID:804
 EP_NO: N/A
 FS_HLM: 7.8333
 Repair Type: Non-Urgent
 Crossing Status: Indicator Found
 UCIP Comments: Unable to find any appurtenances need to coordinate with owner to obtain additional information about crossing. Standpipe appears abandoned. If crossing is no longer in use owner will need to coordinate with DWR inspector and CVFPB to remove according to Title 23 requirements. Unable to determine if crossing is in use.
 FIELD_STRUCT_DESC: Standpipe located on levee crown.
 FS Date: 02/04/2010

Standpipe located on levee crown.

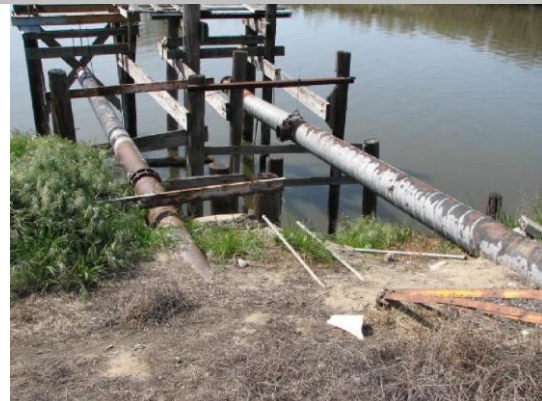
Photo 1 of 3 : UCIP_FA_2015_6681.jpg

Inspector Comments: FS_ID:40687
 DS_ID:100
 EP_NO: 15082
 FS_HLM: 7.845
 Repair Type: Non-Urgent
 Crossing Status: Found
 UCIP Comments: Pumps were removed and no power connection visible. Crossing appears abandoned. If crossing is no longer in use owner will need to coordinate with DWR inspector and CVFPB to remove according to Title 23 requirements. Unable to determine if crossing is in use.
 FIELD_STRUCT_DESC: 1 of 2. 20 inch asphalt coated and wrapped steel irrigation pipe through levee 2.1-feet below the crown. Pump missing from platform on waterward side. Siphon breaker inside 24-inch CMP riser on LS shoulder (Permit No. 15082, 1982).
 FS Date: 02/04/2010

View of waterward side--no pumps present anymore.

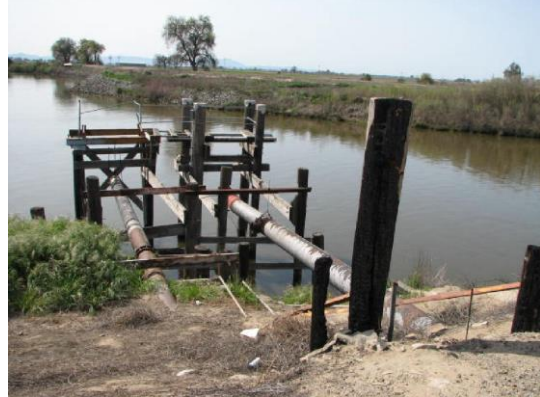
Photo 2 of 3 : UCIP_FA_2015_6682.jpg

View of waterward side.

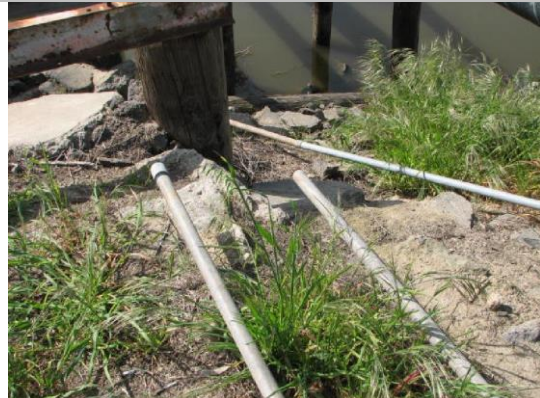
Photo 3 of 3 : UCIP_FA_2015_6683.jpg

Conduit lines present on waterward side--no connection.

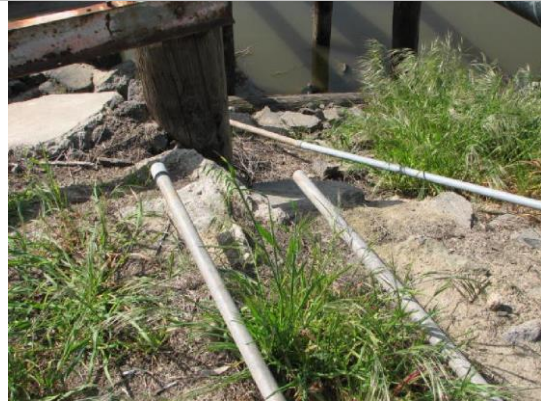
Photo 1 of 3 : UCIP_FA_2015_6852.jpg

Conduits visible on waterward side--no connection.

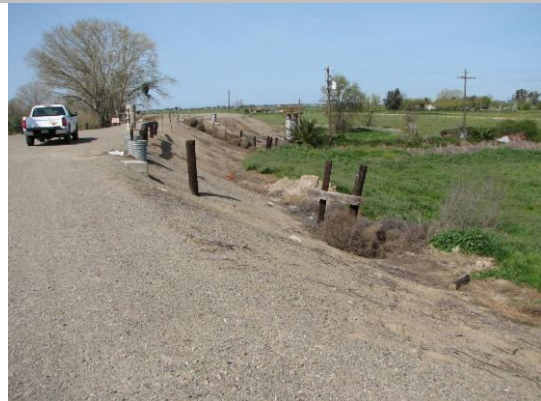
Photo 2 of 3 : UCIP_FA_2015_6853.jpg

View of landward side.

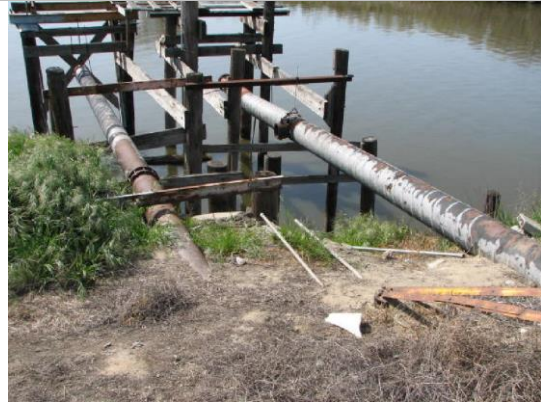
Photo 3 of 3 : UCIP_FA_2015_6854.jpg

View of pipe on waterward side.

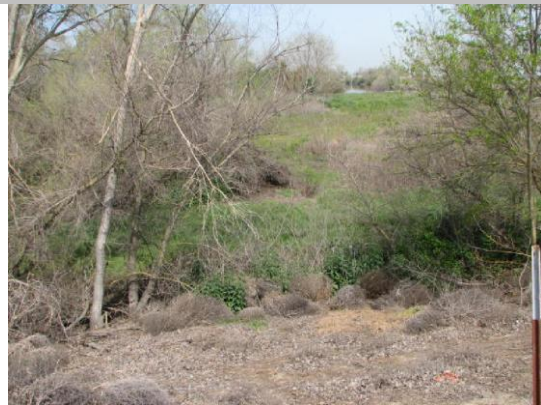
Photo 1 of 3 : UCIP_FA_2015_6855.jpg

View of landward side.

Action/Comments					
Inspector Comments: FS_ID:40689 DS_ID:805 EP_NO: N/A FS_HLM: 7.9861 Repair Type: Non-Urgent Crossing Status: Indicator Found UCIP Comments: Only siphon breakers were found on landward shoulder no other appurtenances were found. If crossing is no longer in use owner will need to coordinate with DWR inspector and CVFPB to remove according to Title 23 requirements. Unable to determine if crossing is in use. FIELD_STRUCT_DESC: Siphon breaker located on landward shoulder. FS Date: 02/04/2010

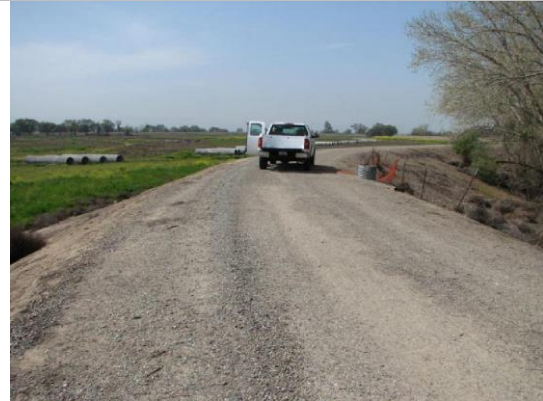
Photo 2 of 3 : UCIP_FA_2015_6856.jpg

View of levee crown at crossing.

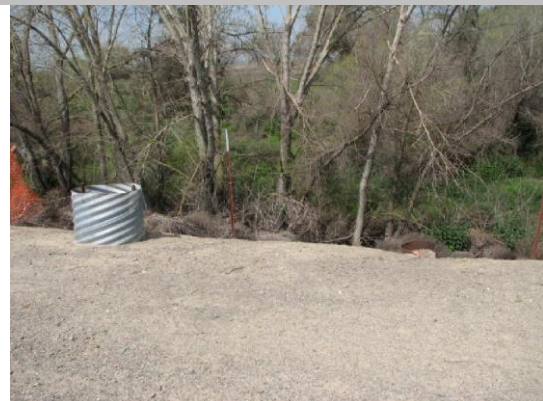
Photo 3 of 3 : UCIP_FA_2015_6857.jpg

CMP riser located on landward side.

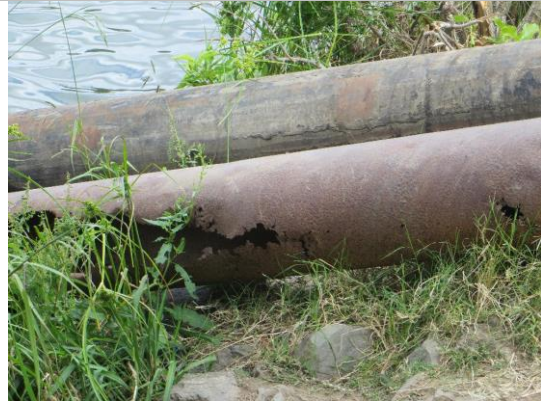
Photo 3 of 3 : UCIP_FA_2015_6016.jpg

(2015) Second pipe visible from waterward side shows wall damage (failure).

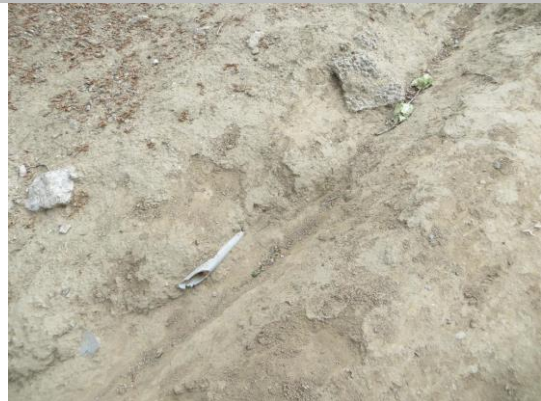
Photo 1 of 2 : UCIP_FA_2015_6318.jpg

Electrical conduit only appurtanance found on WS slope.

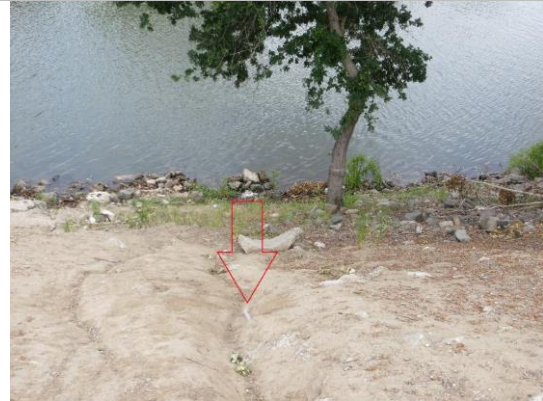
Photo 2 of 2 : UCIP_FA_2015_6319.jpg

1.5-inch electrical conduit only appurtanance still visible on WS slope.

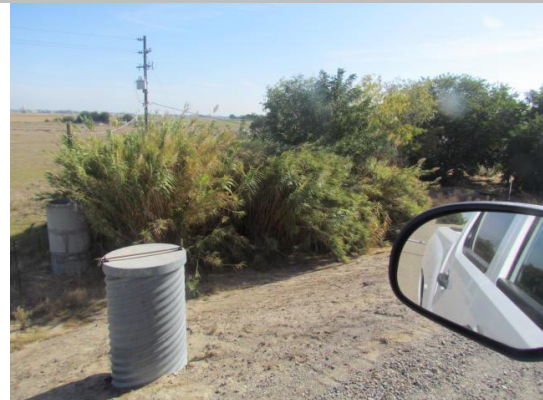
Photo 1 of 1 : FA_2015_RD0017_304_9_20150914_00005.jpg

LM Start	9.28	Rating **	U	Issue No.	9
LM End	9.28	Issue Type +	Ma	Location *	LS
Category	Earthen Levee			GPS Latitude/Longitude	
				Start	End
Item	Vegetation			37.815243 °	37.815243 °
				-121.317470 °	-121.317470 °
DWR ID	DWR_RD0017_02_s_2012_9				
Action/Comments					
Trees / Woody Vegetation					
Inspector Comments: Bamboo located at landward toe.

Looking east at bamboo at landward toe.

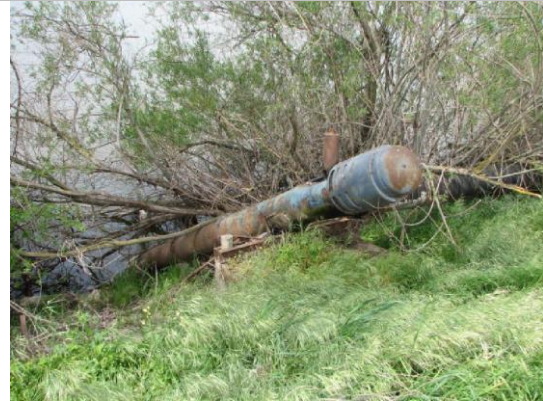
Photo 1 of 3 : UCIP_FA_2015_0694.jpg

Slant pump located on waterward side.

Inspector Comments: FS_ID:40695
 DS_ID:51
 EP_NO: 15055
 FS_HLM: 11.4521
 Repair Type: Non-Urgent
 Crossing Status: Found
 UCIP Comments: Pipe is not connected on waterward side. Crossing is non-functional recommend contacting owner to determine status of crossing. If crossing is no longer used need to coordinate with CVFPB for proper abandonment.
 FIELD_STRUCT_DESC: 16 inch diameter pipe through levee. Invert pipe is 3.91 feet below levee crown. Siphon breaker on landward shoulder. Slant pump on waterward slope, standpipe located 11 feet from the landward toe. (Permit No. 15055-1989)
 FS Date: 02/04/2010

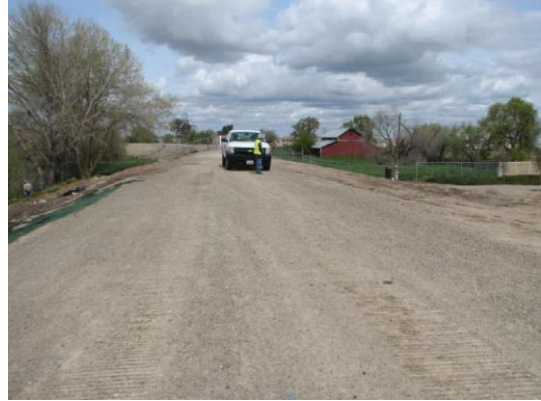
Photo 2 of 3 : UCIP_FA_2015_2265.jpg

Overview of levee crown at crossing.

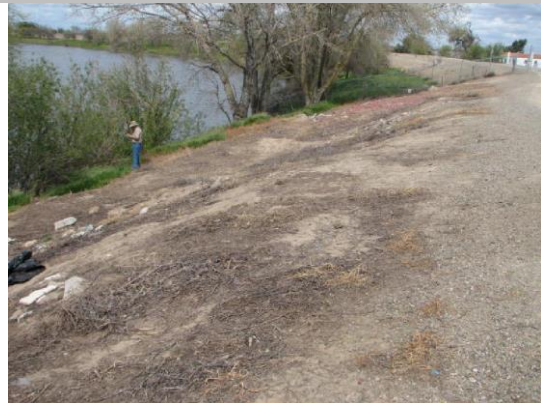
Photo 3 of 3 : UCIP_FA_2015_2504.jpg

View of waterward side.

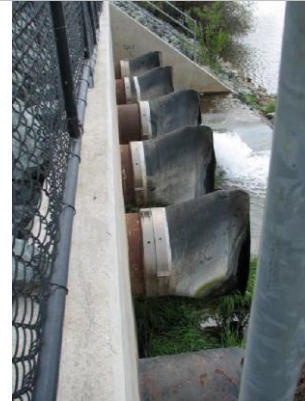
Photo 1 of 3 : UCIP_FA_2015_1838.jpg

Concrete headwall and gates located on waterward toe.

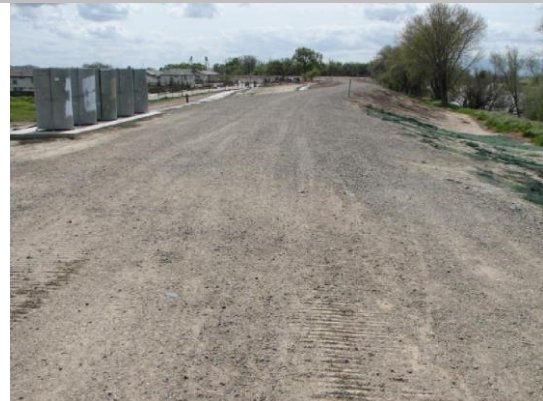
Photo 2 of 3 : UCIP_FA_2015_2264.jpg

Overview of levee crown at crossing.

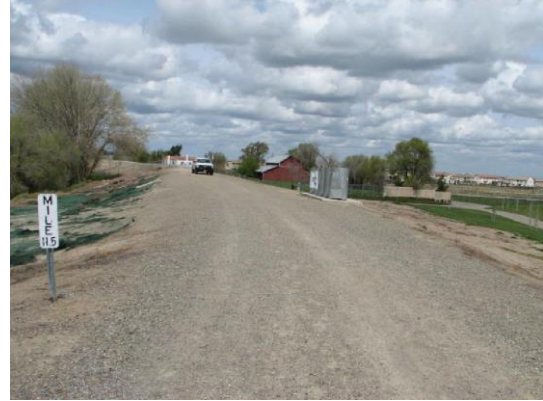
Photo 2 of 3 : UCIP_FA_2015_1864.jpg

Overview of levee crown at crossings.

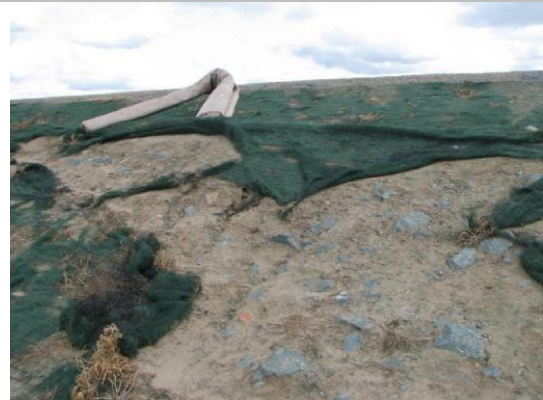
Photo 3 of 3 : UCIP_FA_2015_1868.jpg

Geotech fabric damage along waterward berm.

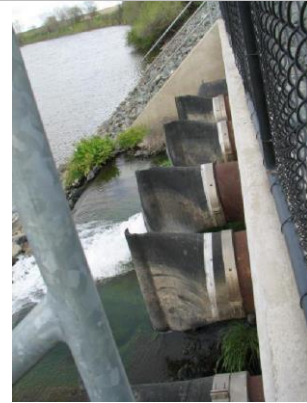
Photo 1 of 3 : UCIP_FA_2015_6426.jpg

Outlet structure located on waterward toe.

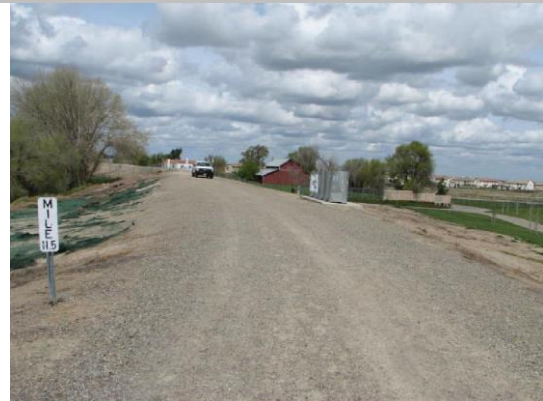
Photo 2 of 3 : UCIP_FA_2015_6427.jpg

Overview of levee crown at crossings.

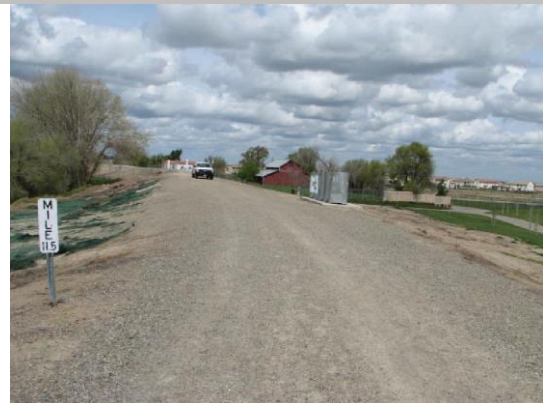
Photo 1 of 3 : UCIP_FA_2015_1869.jpg

Overview of levee crown at crossings.

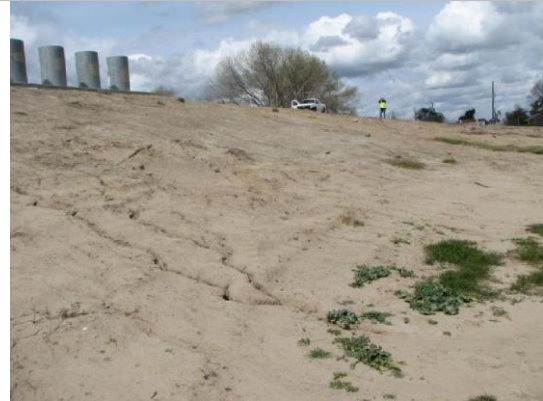
Photo 2 of 3 : UCIP_FA_2015_2531.jpg

View of landward side.

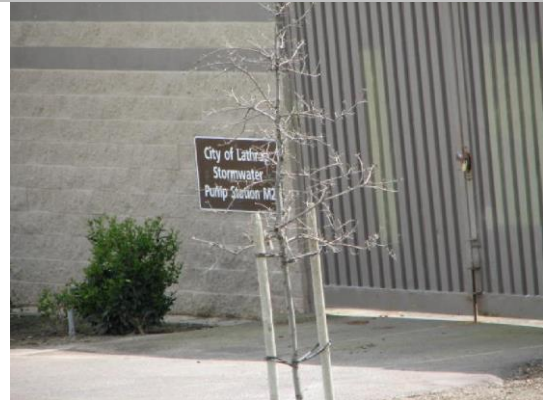
Photo 3 of 3 : UCIP_FA_2015_2532.jpg

City of Lathrop Stormwater Pump Station 112.

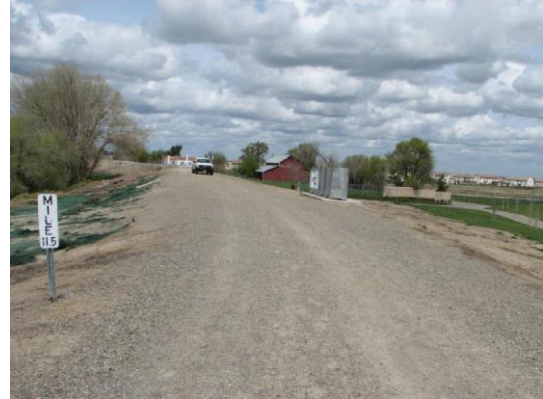
Photo 1 of 3 : UCIP_FA_2015_6420.jpg

Overview of levee crown at crossings.

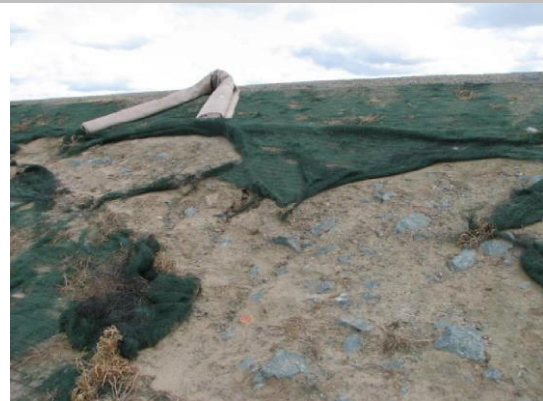
Photo 2 of 3 : UCIP_FA_2015_6421.jpg

Surface erosion on waterward side.

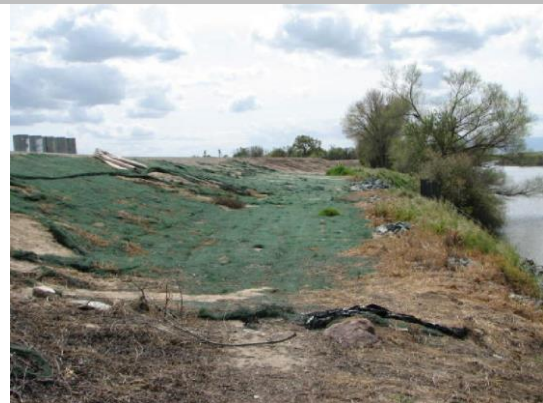
Photo 1 of 3 : UCIP_FA_2015_6423.jpg

View of waterward side.

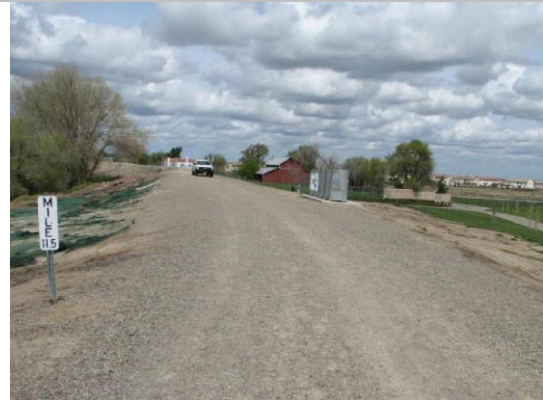
Photo 3 of 3 : UCIP_FA_2015_6425.jpg

Overview of levee crown at crossings.

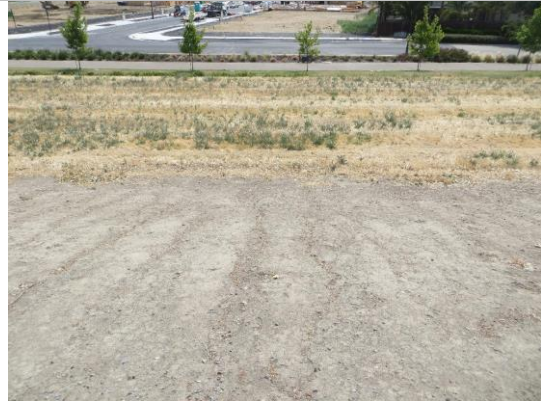
Photo 1 of 3 : UCIP_FA_2015_5791.jpg

LS slope. No indication of pipe.

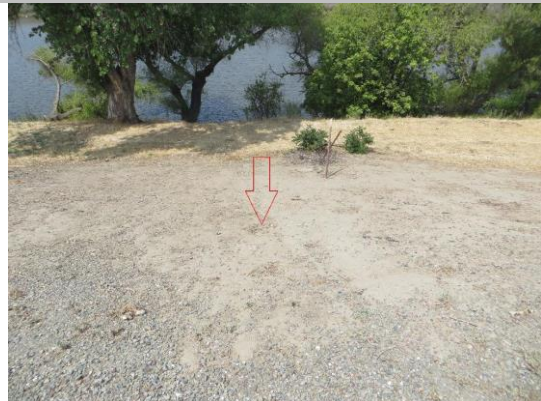
Photo 2 of 3 : UCIP_FA_2015_5792.jpg

Vent visible on WS slope. Found partially buried.

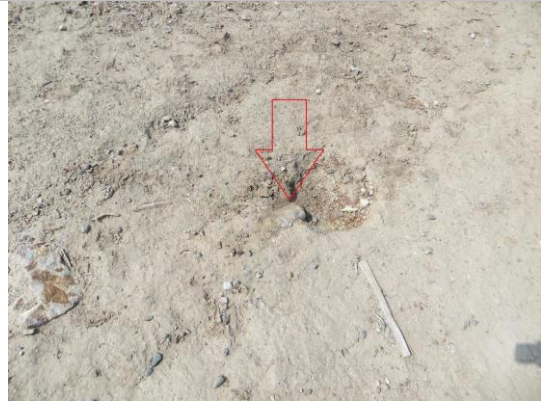
Photo 3 of 3 : UCIP_FA_2015_5793.jpg

Vent visible on WS slope. Found partially buried.

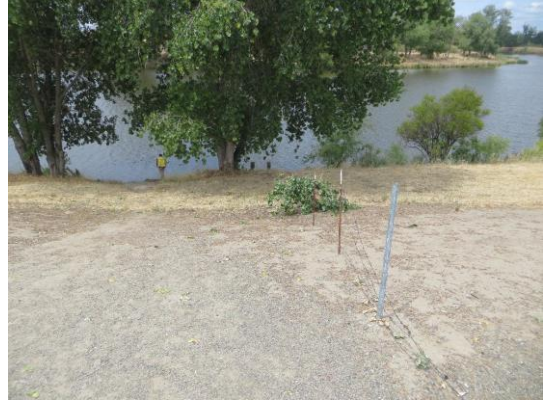
Photo 1 of 3 : UCIP_FA_2015_5794.jpg

View of WS at crossing.

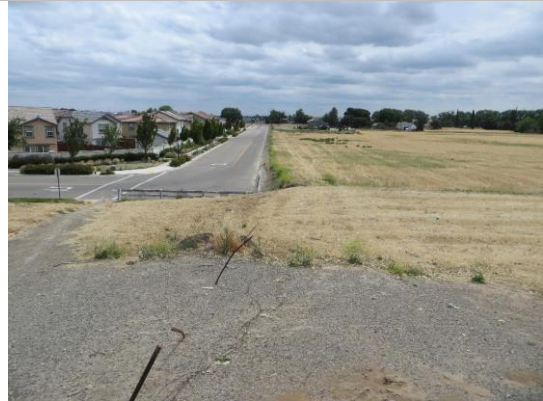
Photo 2 of 3 : UCIP_FA_2015_5795.jpg

View of LS at crossing.

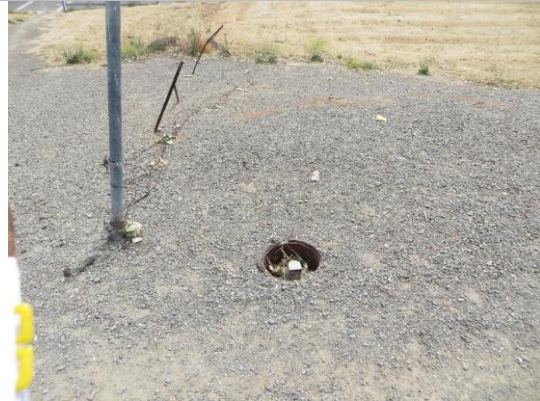
Photo 3 of 3 : UCIP_FA_2015_5796.jpg

Vent in steel riser on LS shoulder.

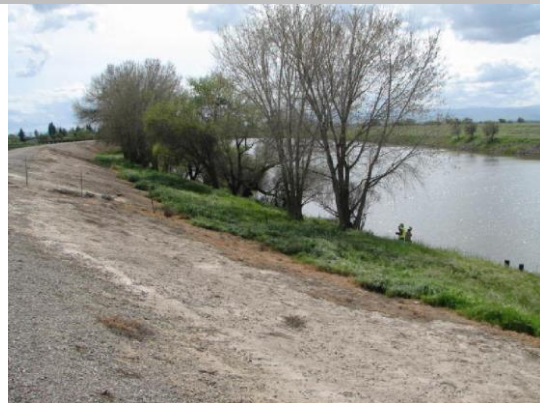
Photo 1 of 3 : UCIP_FA_2015_6429.jpg

View of waterward side.

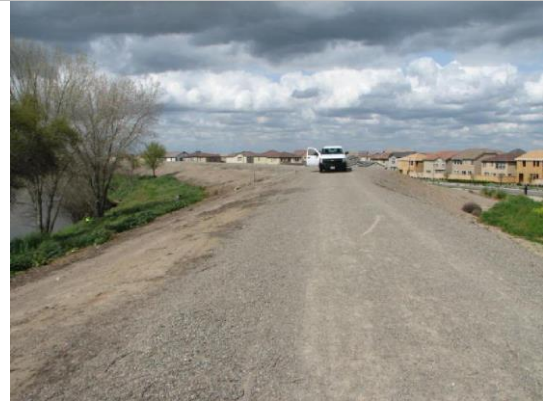
Photo 2 of 3 : UCIP_FA_2015_6430.jpg

Overview of levee crown at crossing.

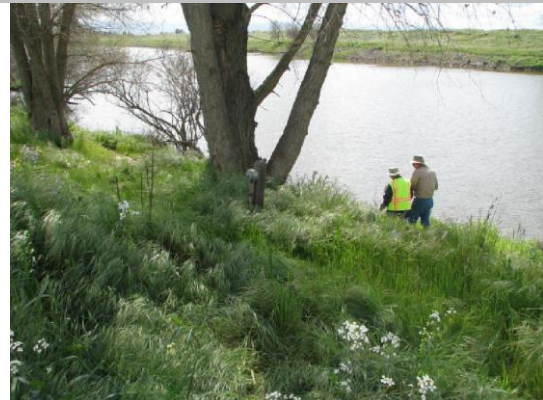
Photo 3 of 3 : UCIP_FA_2015_6465.jpg

Dense vegetation along waterward slope--abandoned electrical box is visible through dense vegetation.

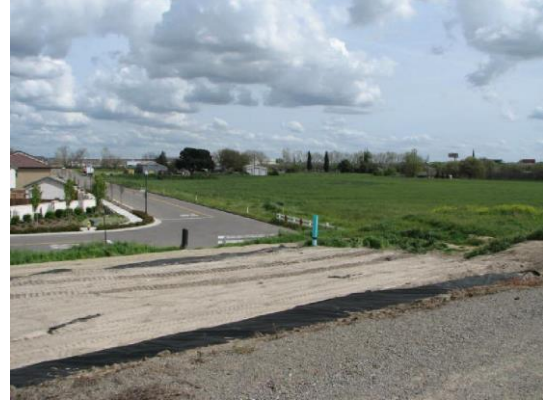
Photo 1 of 3 : UCIP_FA_2015_6466.jpg

View of landward side, photo 1 of 2.

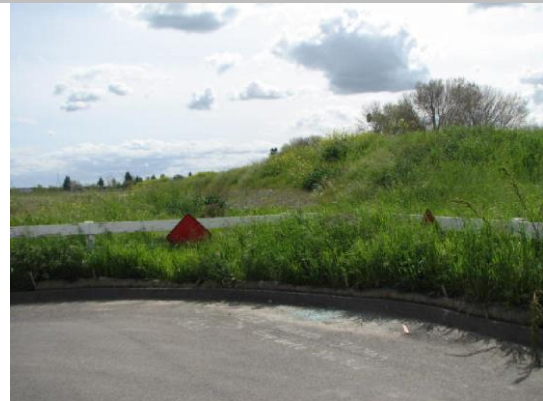
Photo 2 of 3 : UCIP_FA_2015_6467.jpg

View of landward side, photo 2 of 2.

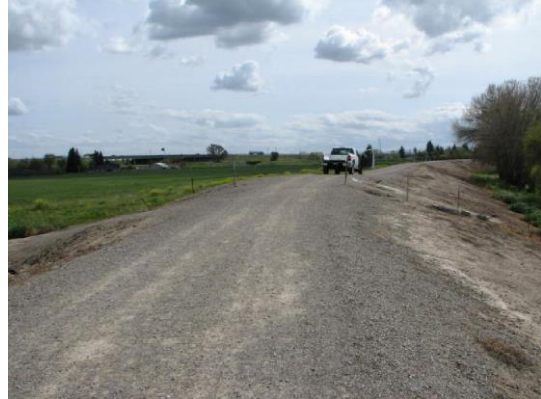
Photo 3 of 3 : UCIP_FA_2015_6468.jpg

Overview of levee crown at crossings.

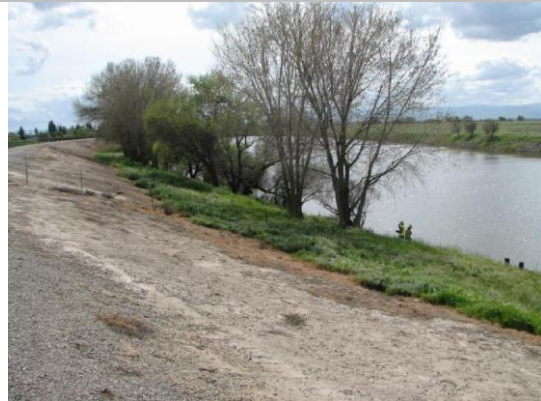
Photo 1 of 3 : UCIP_FA_2015_6469.jpg

View of waterward side.

Inspector Comments: FS_ID:45993
 DS_ID:800
 EP_NO: 15845
 FS_HLM: 12.293
 Repair Type: Non-Urgent
 Crossing Status: Found
 UCIP Comments: Need to contact owner to determine status of crossing and obtain additional information about crossing (permit and install date).
 FIELD_STRUCT_DESC: 2 of 2. 12 inch drainage pipe through levee at unknown depth. Concrete "U" wall located on waterward side. Flap gate on waterward side. 8-4 inch steel coated scheduled 40 pipes located on waterward shoulder about 6 inch cover. Seepage berm located on landward side.
 FS Date: 02/04/2010

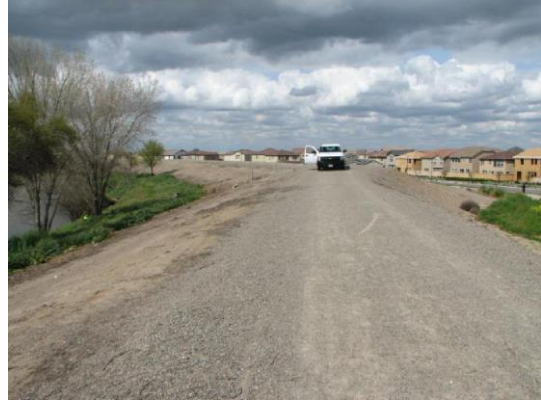
Photo 2 of 3 : UCIP_FA_2015_6470.jpg

Overview of levee crown at crossing.

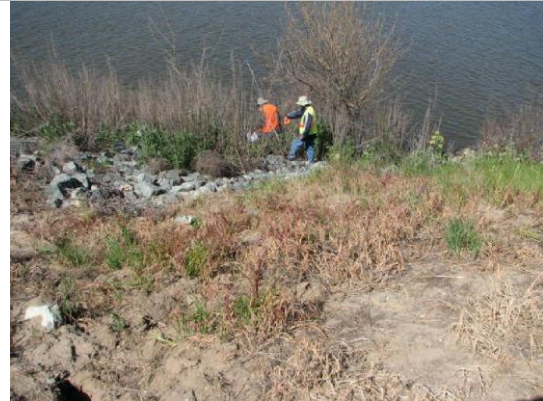
Photo 1 of 3 : UCIP_FA_2015_5515.jpg

View of waterward toe--rip rap along pipe alignment.

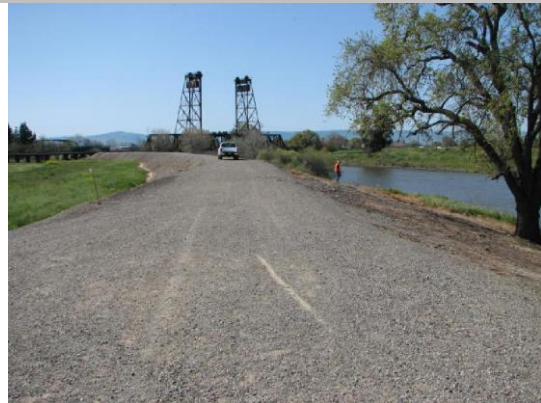
Photo 3 of 3 : UCIP_FA_2015_6120.jpg

Overview of levee crown at crossing.

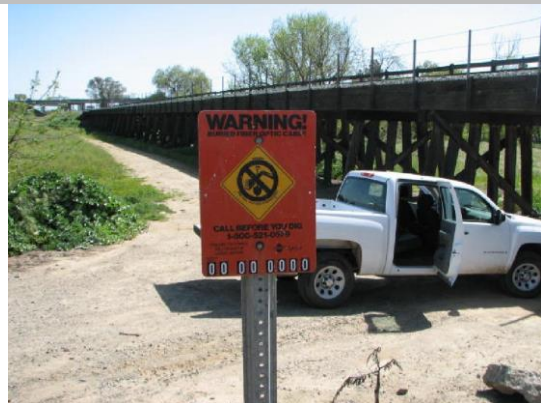
Photo 1 of 3 : UCIP_FA_2015_5517.jpg

LM Start	12.55	Rating **	M	Issue No.	624
LM End	12.55	Issue Type +	En	Location *	LS
Category	Supplemental			GPS Latitude/Longitude	
				Start	End
Item	DWR UCIP Field Study			37.787929 °	37.787929 °
				-121.307173 °	-121.307173 °
DWR ID					
Action/Comments					
Inspector Comments: FS_ID:40707					
DS_ID:60					
EP_NO: 14326					
FS_HLM: 12.7115					
Repair Type: Non-Urgent					
Crossing Status: Indicator Found					
UCIP Comments: Wires exposed near levee crown unable to determine if these wires are part of the crossing. Need to contact owner to determine status of crossing.					
FIELD_STRUCT_DESC: 4 inch diameter communication cable through levee. Invert of conduit is 3.0 feet below levee crown. (Permit No. 14326-1986)					
FS Date: 02/04/2010

Conduit marker on landward side.

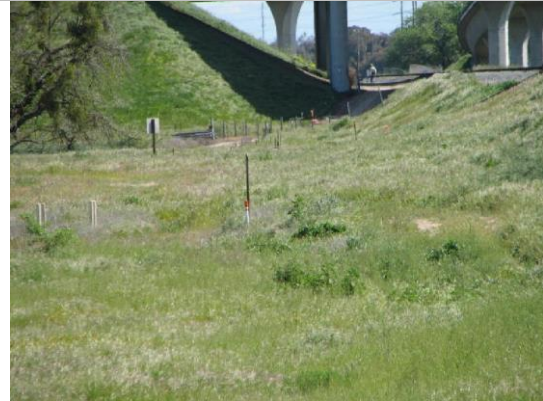
Photo 2 of 3 : UCIP_FA_2015_5518.jpg

Inspector Comments: FS_ID:40707
 DS_ID:60
 EP_NO: 14326
 FS_HLM: 12.7115
 Repair Type: Non-Urgent
 Crossing Status: Indicator Found
 UCIP Comments: Wires exposed near levee crown unable to determine if these wires are part of the crossing. Need to contact owner to determine status of crossing.
 FIELD_STRUCT_DESC: 4 inch diameter communication cable through levee. Invert of conduit is 3.0 feet below levee crown. (Permit No. 14326-1986)
 FS Date: 02/04/2010

Crossing alignment along landward side.

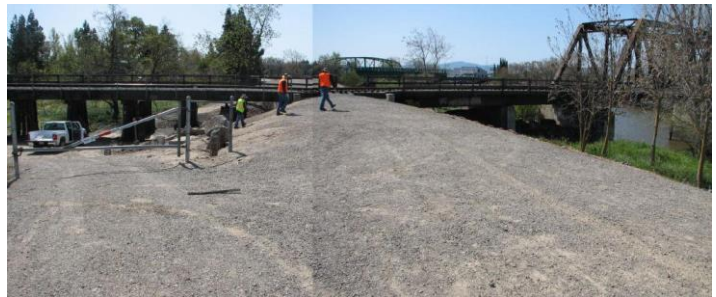
Photo 3 of 3 : UCIP_FA_2015_5519.jpg

Overview of levee crown at crossing.

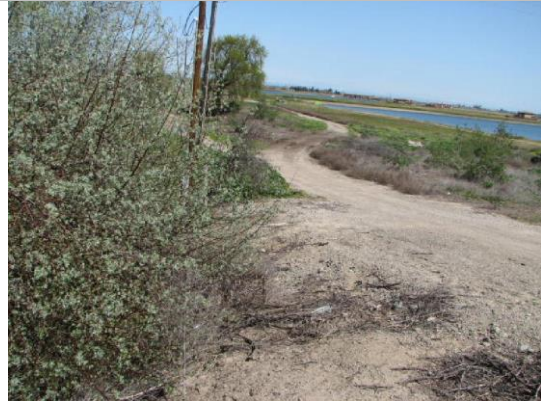
Photo 2 of 3 : UCIP_FA_2015_5524.jpg

LM Start	13.26	Rating **	M	Issue No.	626 (cont)	
LM End	13.26	Issue Type +	En	Location *	LS	
Category	Supplemental			GPS Latitude/Longitude		
				Start	End	
Item	DWR UCIP Field Study			37.779653 °	37.779653 °	
				-121.300064 °	-121.300064 °	
DWR ID						
Action/Comments						
Inspector Comments: FS_ID:40712						
DS_ID:65						
EP_NO: 14450						
FS_HLM: 13.4304						
Repair Type: Non-Urgent						
Crossing Status: Found						
UCIP Comments: Need to contact owner to determine status of crossing.						
FIELD_STRUCT_DESC: 1 of 2: 18 inch diameter drainage discharge pipes through levee. (Permit No. 14450-1985)						
FS Date: 02/04/2010

View of landward side.

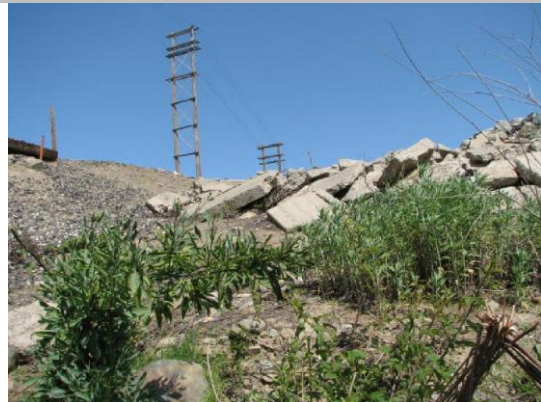
Photo 3 of 3 : UCIP_FA_2015_5525.jpg

View of waterward slope.

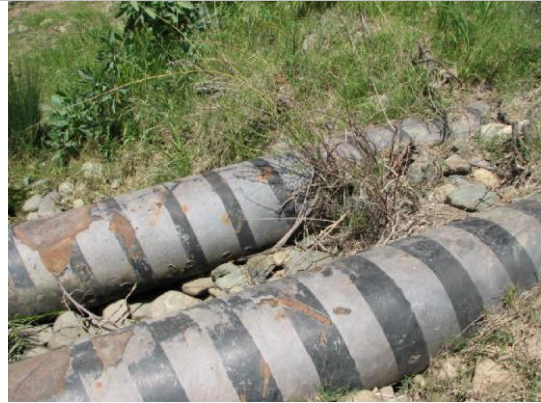
Photo 1 of 3 : UCIP_FA_2015_5522.jpg

LM Start	13.26	Rating **	M	Issue No.	627
LM End	13.26	Issue Type +	En	Location *	LS
Category	Supplemental			GPS Latitude/Longitude	
				Start	End
Item	DWR UCIP Field Study			37.779643 °	37.779643 °
				-121.300057 °	-121.300057 °
DWR ID					
Action/Comments					
Inspector Comments: FS_ID:40713					
DS_ID:287					
EP_NO: 14450					
FS_HLM: 13.431					
Repair Type: Non-Urgent					
Crossing Status: Found

Pipes visible on waterward side.

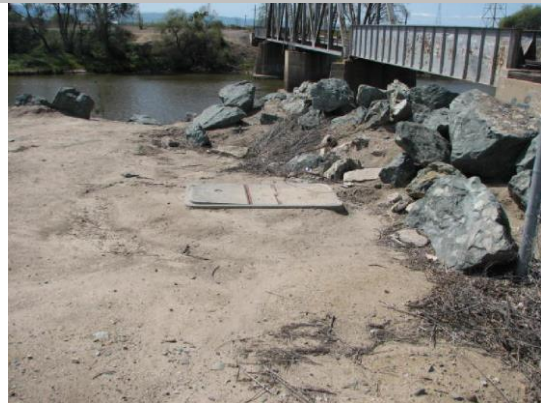
Photo 2 of 3 : UCIP_FA_2015_6233.jpg

Precast concrete box located on levee shoulder.

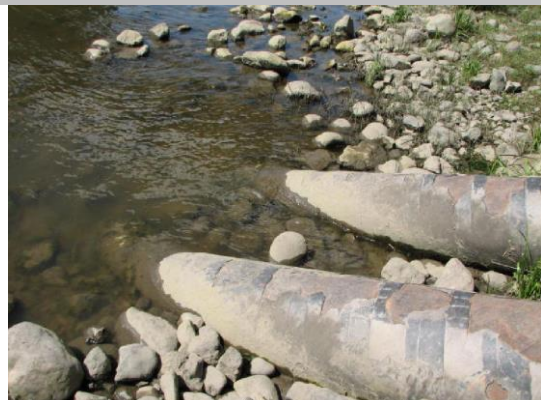
Photo 3 of 3 : UCIP_FA_2015_6235.jpg

Sections of protective wrap missing near waterward toe.

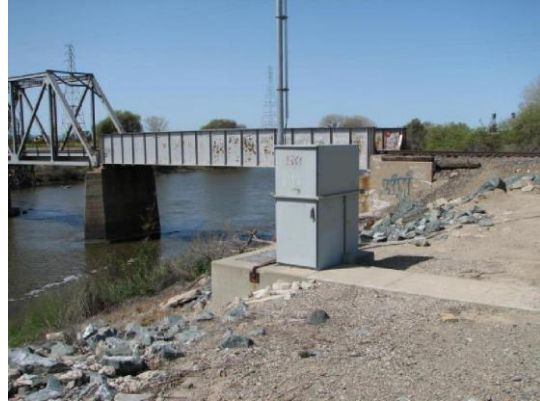
Photo 1 of 3 : UCIP_FA_2015_6234.jpg

LM Start	13.27	Rating **	M	Issue No.	628
LM End	13.27	Issue Type +	En	Location *	LS
Category	Supplemental			GPS Latitude/Longitude	
				Start	End
Item	DWR UCIP Field Study			37.779546 °	37.779546 °
				-121.299981 °	-121.299981 °
DWR ID					
Action/Comments					
Inspector Comments: FS_ID:40714					
DS_ID:66					
EP_NO: 14467					
FS_HLM: 13.4387					
Repair Type: Non-Urgent					
Crossing Status: Found

Control box and distribution box located on waterward shoulder.

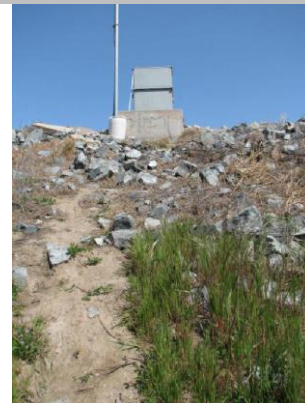
Photo 2 of 3 : UCIP_FA_2015_6275.jpg

View of waterward side.

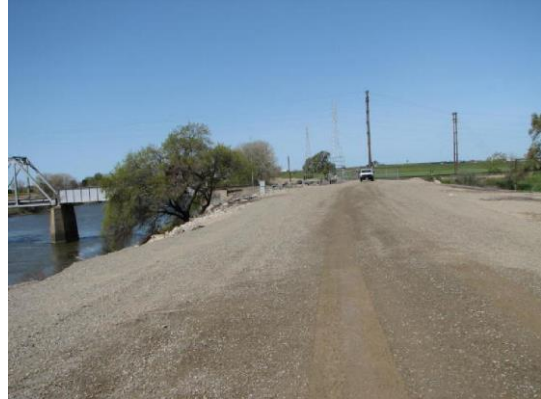
Photo 3 of 3 : UCIP_FA_2015_6276.jpg

Overview of levee crown at crossing.

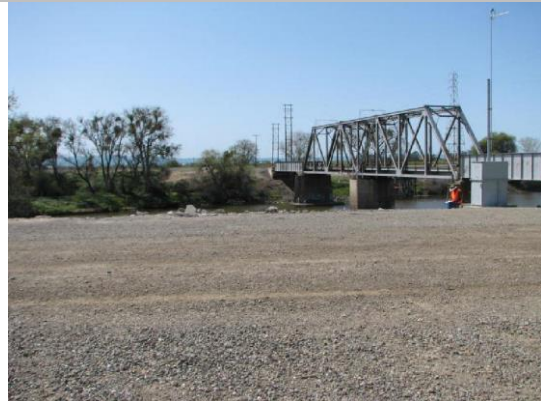
Photo 1 of 3 : UCIP_FA_2015_6277.jpg

LM Start	13.28	Rating **	M	Issue No.	629
LM End	13.28	Issue Type +	En	Location *	LS
Category	Supplemental			GPS Latitude/Longitude	
				Start	End
Item	DWR UCIP Field Study			37.779470 °	37.779470 °
				-121.299954 °	-121.299954 °
DWR ID					
Action/Comments					
Inspector Comments: FS_ID:40715 DS_ID:809 EP_NO: N/A FS_HLM: 13.4439 Repair Type: Non-Urgent Crossing Status: Found UCIP Comments: No information was obtained from desk study. This crossing was found during field visit. Need to contact owner to obtain additional details about crossing (installation date and permit) and status. FIELD_STRUCT_DESC: *ABANDONED* 18-inch pipe through the levee, 5.8 feet below the crown. Gate valve and siphon breaker on the waterward slope. Flap gate on the waterward end. One CM cutoff wall (Reclamation District No. 17 Drainage Plant). Pump on the landward side. Installed by USCE 1961. This entry matches the Drainage or Irrigation Structure referenced in O&M manual (HLM 13.36). (USACE O&M, 1963). Welded Steel plate installed over one end of pipe under Permit No. 14450, 1988. FS Date: 02/04/2010

View of levee crown at crossing.

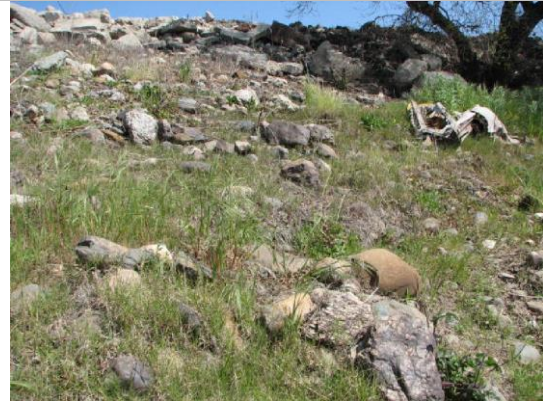
Photo 2 of 3 : UCIP_FA_2015_6278.jpg

Action/Comments					
Inspector Comments: FS_ID:40715 DS_ID:809 EP_NO: N/A FS_HLM: 13.4439 Repair Type: Non-Urgent Crossing Status: Found UCIP Comments: No information was obtained from desk study. This crossing was found during field visit. Need to contact owner to obtain additional details about crossing (installation date and permit) and status. FIELD_STRUCT_DESC: *ABANDONED* 18-inch pipe through the levee, 5.8 feet below the crown. Gate valve and siphon breaker on the waterward slope. Flap gate on the waterward end. One CM cutoff wall (Reclamation District No. 17 Drainage Plant). Pump on the landward side. Installed by USCE 1961. This entry matches the Drainage or Irrigation Structure referenced in O&M manual (HLM 13.36). (USACE O&M, 1963). Welded Steel plate installed over one end of pipe under Permit No. 14450, 1988. FS Date: 02/04/2010

View of waterward side, photo 2 of 2.

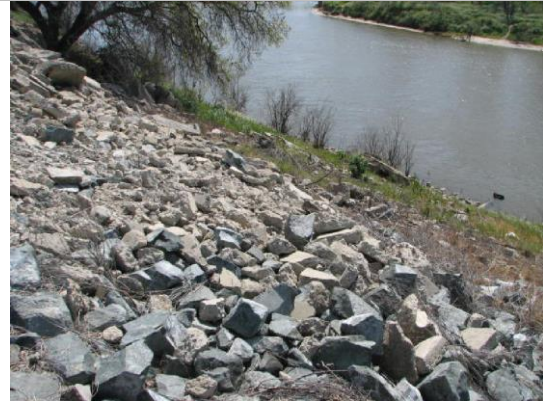
Photo 3 of 3 : UCIP_FA_2015_6279.jpg

View of waterward side, photo 1 of 2.

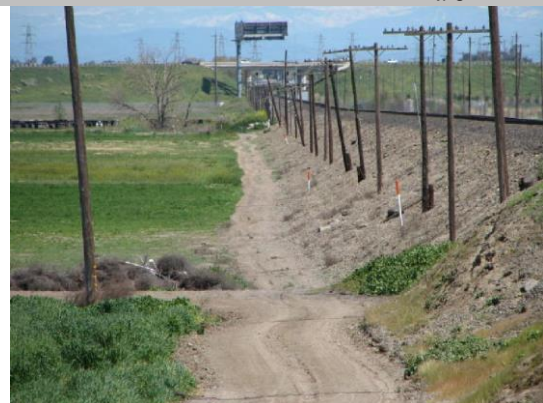
Photo 1 of 2 : UCIP_FA_2015_5520.jpg

Inspector Comments: FS_ID:45995
 DS_ID:67
 EP_NO: N/A
 FS_HLM: 13.41
 Repair Type: Non-Urgent
 Crossing Status: Indicator Found
 UCIP Comments: Markers visible on landward side only. Recommend contacting owner to confirm alignment and crossing.
 FIELD_STRUCT_DESC: Submarine power cable through the levee and across the channel.
 FS Date: 02/04/2010

Markers visible along landward side.

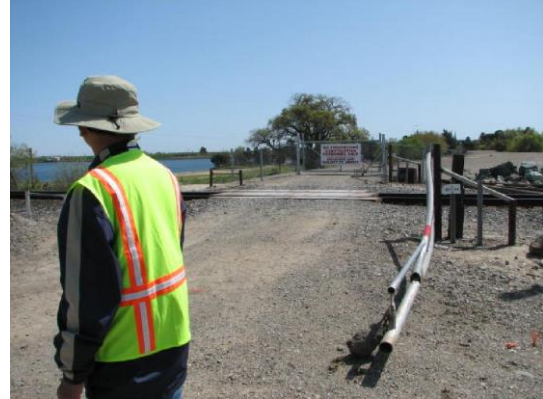
Photo 2 of 2 : UCIP_FA_2015_5521.jpg

View of levee crown at crossing.

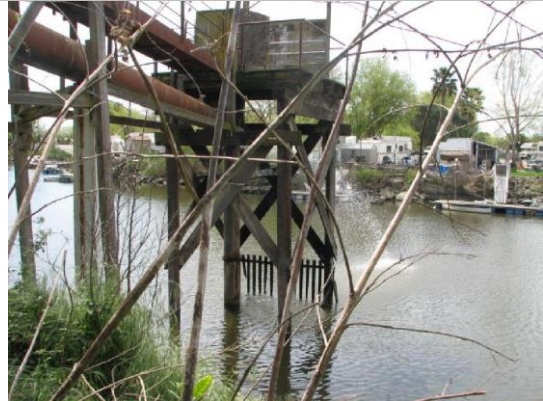
Photo 2 of 3 : UCIP_FA_2015_6281.jpg

LM Start	14.20	Rating **	M	Issue No.	631 (cont)	
LM End	14.20	Issue Type +	En	Location *	LS	
Category	Supplemental			GPS Latitude/Longitude		
				Start	End	
Item	DWR UCIP Field Study			37.772267 °	37.772267 °	
				-121.290202 °	-121.290202 °	
DWR ID						
Action/Comments						
Inspector Comments: FS_ID:40716 DS_ID:69 EP_NO: 15165 FS_HLM: 14.3852 Repair Type: Non-Urgent Crossing Status: Found UCIP Comments: Pump was working during the survey. Levee toe erosion at waterward side. Recommend contacting owner to determine status and to evaluate erosion at waterward toe. FIELD_STRUCT_DESC: 20-inch pipe through the levee, 1.7-feet below the crown. Pump on pile structure in the stream. Wooden walkway to the pump. concrete distribution box at the toe of the landward slope. (Permit No. 15165-1989) FS Date: 02/04/2010

Pipe operable during survey.
